LAYDON INDUSTRIES, LLC

CLIENT: Greater New Haven Water Pollution Control Authority (GNHWPCA)

PROJECT: Rehabilitate Failing 30" Pressure Sewer Main

LOCATION: Hamden, CT

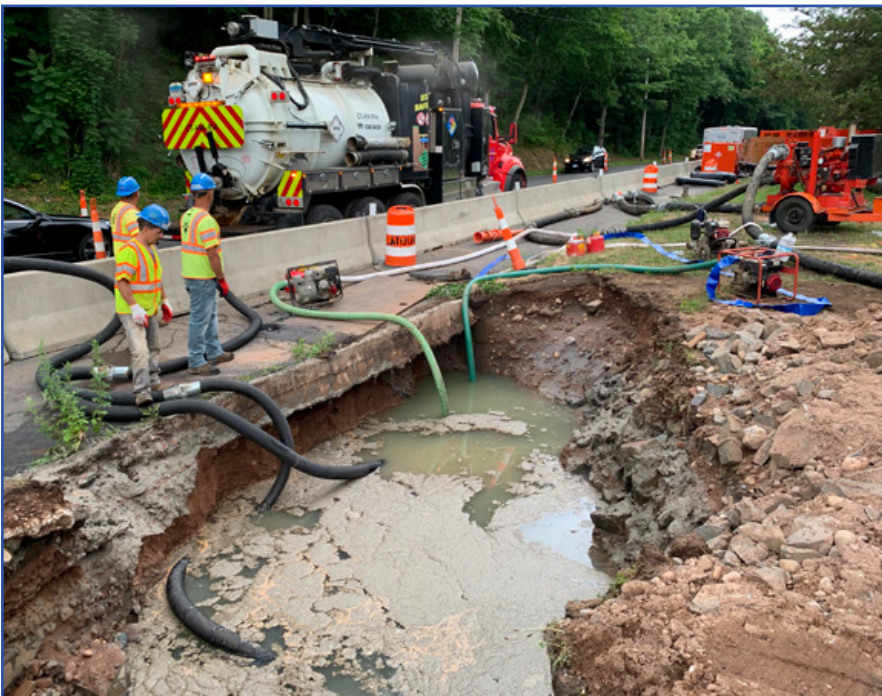
Sewage pipe collapse being drained with a combination of vacuum tanker trucks and a series of 6" and 8" portable pumps.

However, on Monday, July 6th, at about 6:00am, one day before the lining work was to commence, the existing 30" sewer main suddenly collapsed.

Laydon was notified that the collapse caused raw sewage to run down the street. Within minutes, Laydon's crew was mobilized and emergency bypass operations were being set up to contain the overflow sewage.

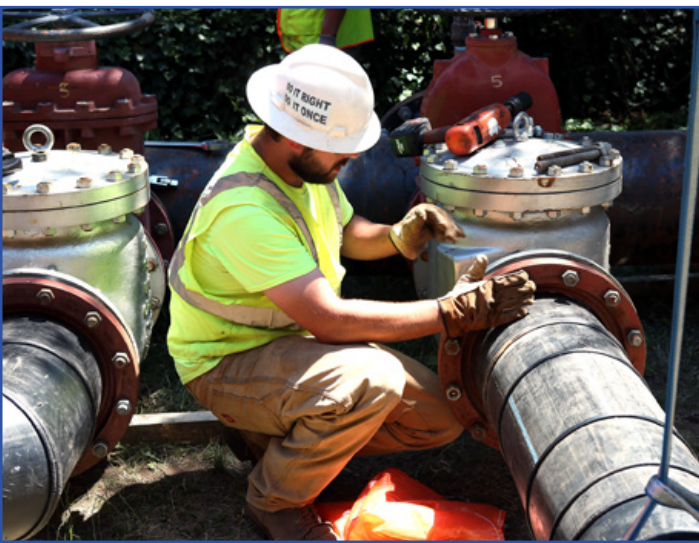
Custom made bypass manifolds using a combination of cast iron, steel, and HDPE components.

The first phase of the project involved the installation of a bypass pumping system, tapping sections, and line stop in order to replace approximately 140 LF of 30" sewer main using open cut techniques.

A 400' semi permanent bypass system was installed using 18" HDPE pipe that was fused onsite and connected to one 8" and two 12" pumps.

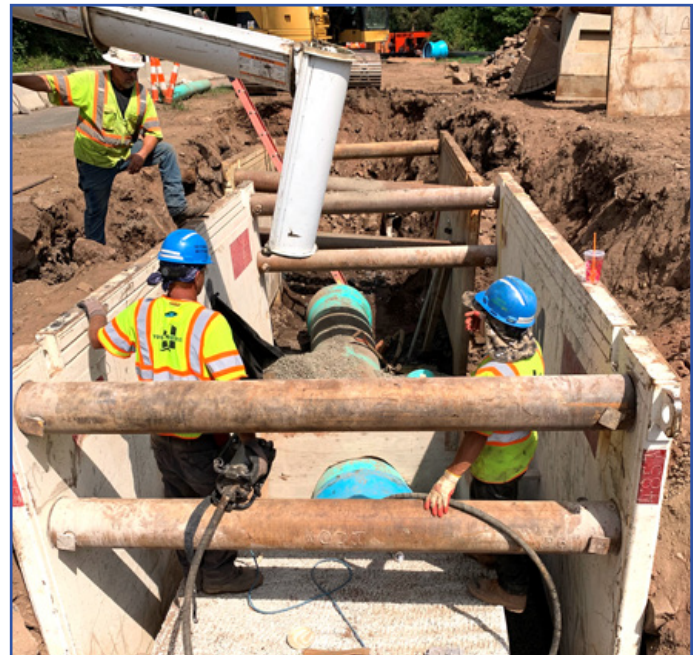
Crews replace the 30" pipe and encase all the fittings with concrete thrust blocks.

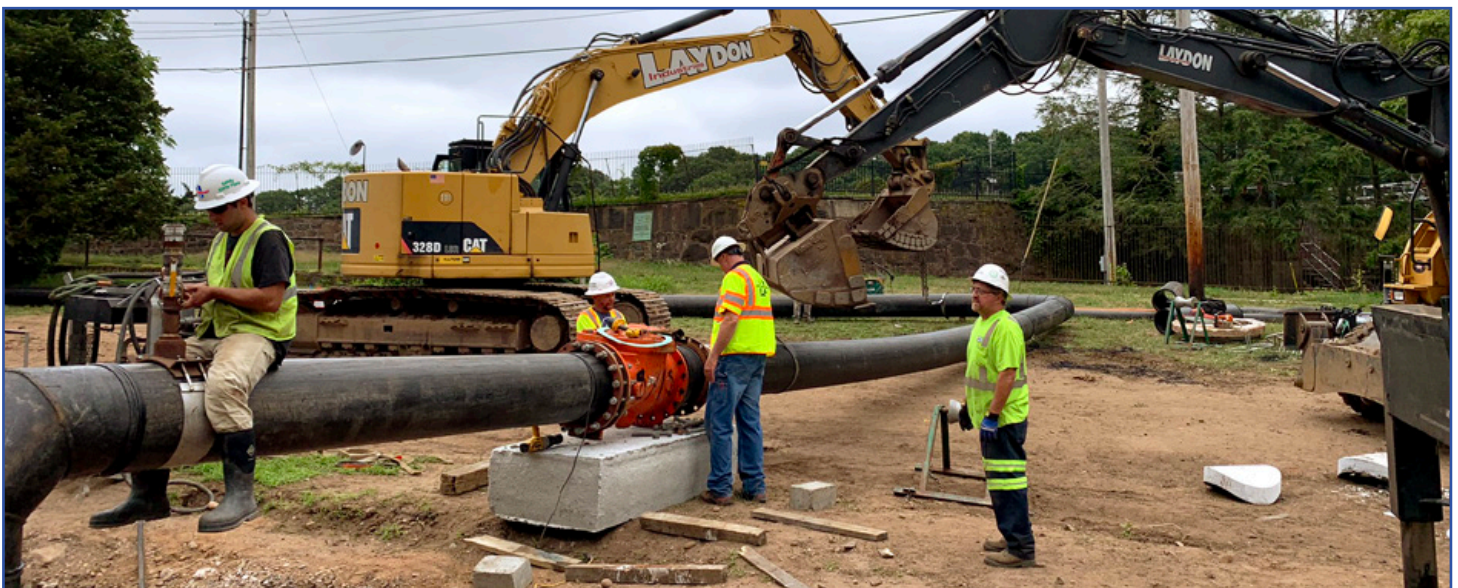
Crews working on assembling the semi-permanent 18" HDPE bypass line.

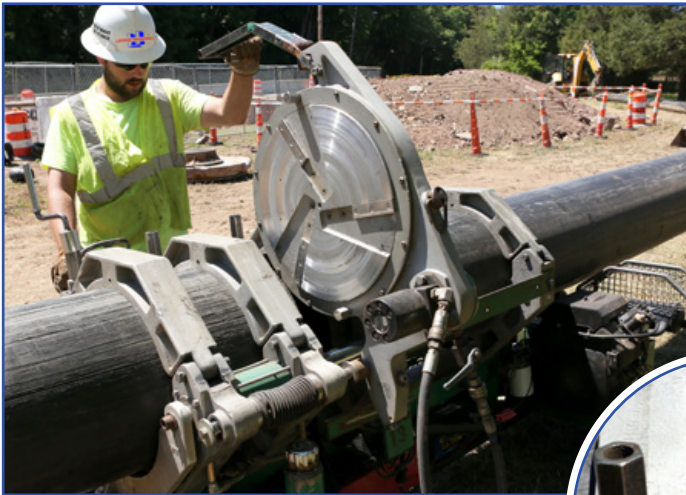
Plastic line piping sections are cut and then welded via a high heat fusion process.

This phase included an additional 550 LF of 18" welded HDPE piping to bypass the work area. Thankfully, this area was able to be rehabilitated using liner technology and disturbances during phase 2 were kept to a minimum.

Laydon established a similar three pump installation and fused 550' of 18" HDPE to bypass the area requiring the 30" pipe lining. A custom line stop and two taps were again installed into the pressure main allowing access for the liner installation.

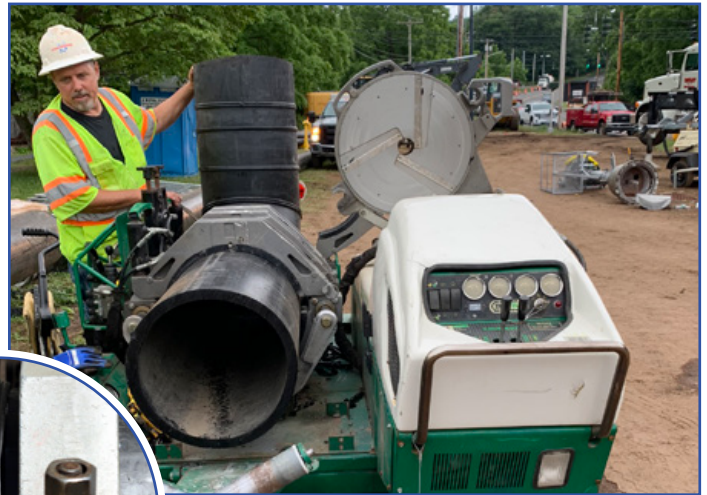
Straight and radius piping configurations are custom fabricated onsite.

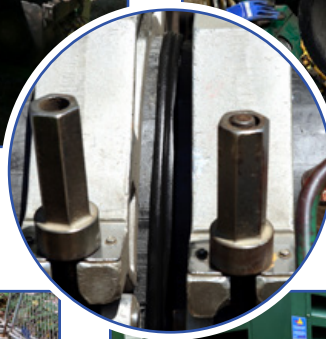
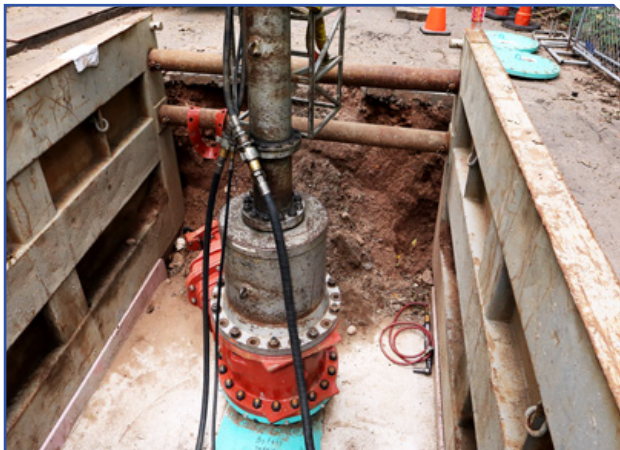
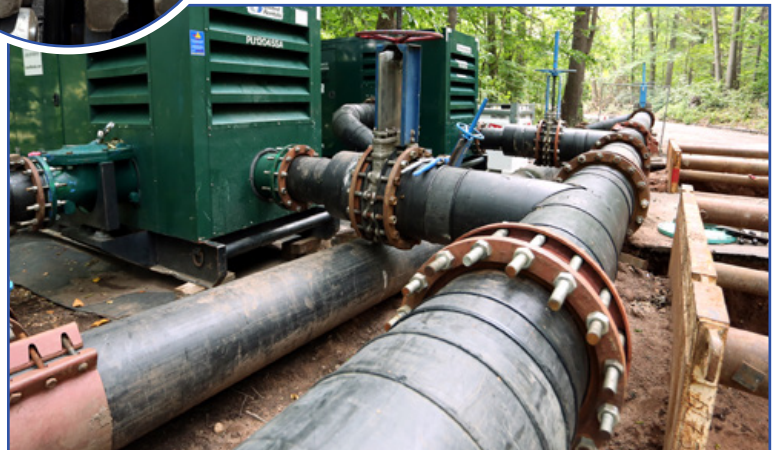
Laydon is not only a utility contractor but also an environmental emergency response contractor. Having these two services combined proved to be useful containing the spill and repairing the pipe throughout the event. GNHWPCA immediately commenced incident command protocols and coordinated the response and repairs flawlessly with all agencies involved. Professionals that later visited the site were all impressed with the amount of work that was performed in such a short window.

A special thanks to the Southern Connecticut Gas company who in the overnight hours of the line stop installation lent the project a piece of 16" steel pipe that was used to replace a missing coupling that failed to make the emergency journey from Texas to Connecticut. Laydon's fabricators welded flanges on this pipe to manufacture the missing coupling and the project didn't miss a beat.
